Evaluation Report 172

Demco Model LPW 560 Field Sprayer

DEMCO MODEL LPW 560 FIELD SPRAYER

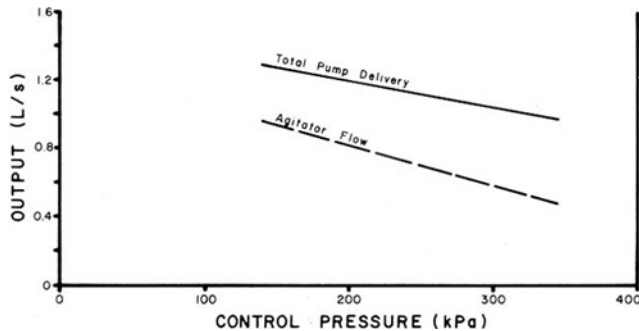
Agitation Capability: Pump output, as is characteristic of centrifugal pumps, was very sensitive to restrictions created by hose friction, valves, nozzles and other accessories. The manufacturer's rated pump output was 6.4 L/s (85 gal/min) at 275 kPa (40 psi), but the maximum pump delivery (FIGURE 9) through the sprayer system when equipped with Delavan LF-2 (80°) nozzles was only 1.08 L/s (14.3 gal/min). Of this total delivery, 0.64 L/s (8.5 gal/min) was Supplied to the tank agitators. Normally recommended

FIGURE 9. Pump Output Through the Sprayer System and Resulting Agitation Flow, when Equipped with Delavan LF-2 (80°) Nozzles.

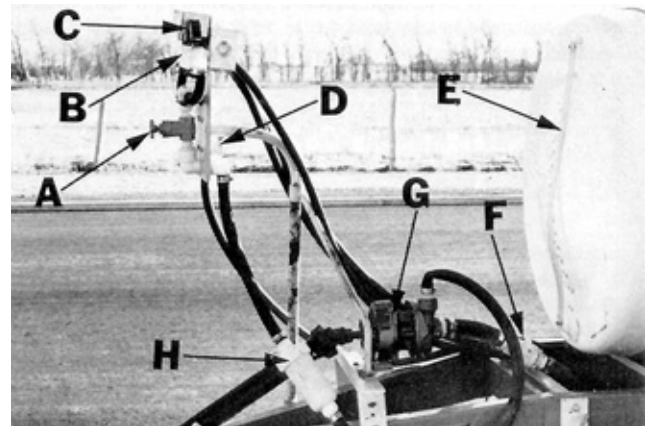
with the agitator valve than with the boom control valve. Small adjustments of the boom control valve resulted in large pressure changes. The boom and agitation control valves became very difficult to turn after about 30 hours of field use. This added to the difficulty of obtaining the desired spraying pressure with the boom control valve. Modifications are recommended to simplify pressure adjustment.

FIGURE 11. Controls: (A) Boom Control Valve, (B) Solenoid Valves, (C) Pressure Gauge, (D) Agitator Valve, (E) Liquid Level Indicator, (F) Shut-off Valve, (G) Pump, (H) Line Strainer.

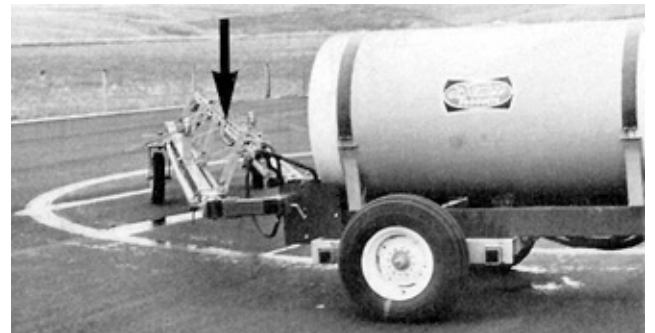
The Demco had a turning radius of 7 m (23 ft) in transport position which provided sufficient maneuverability. The turning radius was limited by boom interference (FIGURE 12). Backing the sprayer in transport position was difficult. The sprayer towed well at all normal road transport speeds.

FIGURE 12. Boom Interference when Making Sharp Turns.

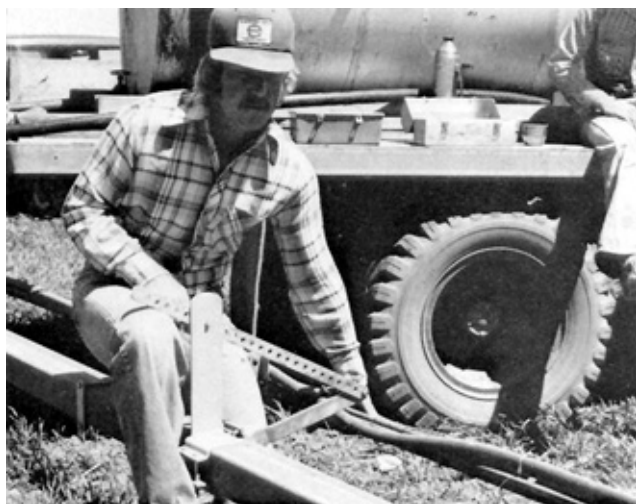
Nozzle Adjustment: Nozzle height could be adjusted without the use of tools. However, this was awkward since the operator had to simultaneously hold the boom support rail in position, pull the adjusting pin and align the adjusting bar hole with the pin (FIGURE 14). Modifications are recommended to make boom height adjustment more convenient.

FIGURE 14. Operator Aligning Nozzle Height, Adjusting Bar with his Knee.
